**3201 BOWMAN AVENUE
AUSTIN, TX**

PROPERTY INSPECTION REPORT

Concerning: 3201 BOWMAN AVENUE, AUSTIN, TX

08/12/2014

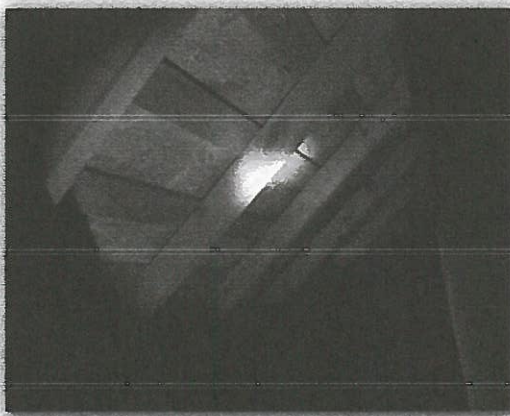
Note: 2 x 4 Rafters and original Skip-Sheathing support the more recently installed solid Decking for the Asphalt Shingle Roofing.

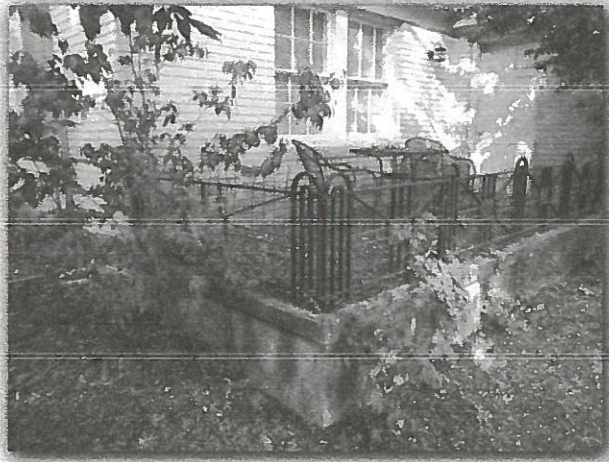
Porches are concrete formed over fill rubble.

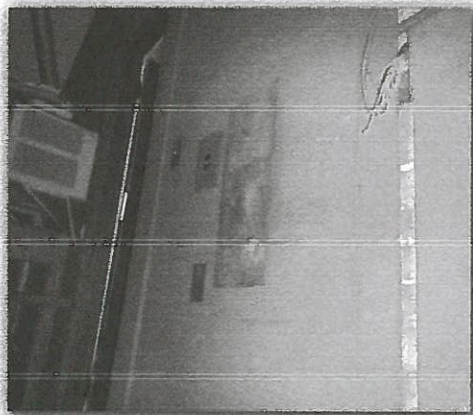
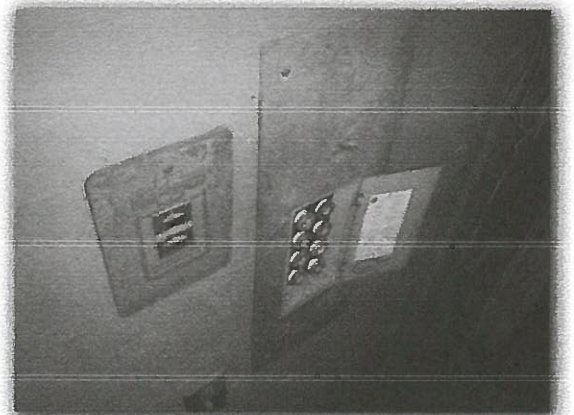
- **This is no longer viable** since a PVC Connector in the Crawlspace bridges the Crawlspace Steel Water Main (right photo) to the Copper Crawlspace Tubing.
- **New Electrical Service** will involve a new Grounding Rod where the new Meter and Main Breaker Box is to be located.
- **All Metallic Water Supply** will then be Bonded back to this new Grounding.
- **Gas Supply Tubing** must also be Bonded back to Grounding.
- **Original Fuse/Switch Boxes** in Garage Wall by Entry Steps to be replaced either at a new Exterior Main Breaker Box, or a new Sub Panel in the rebuilt Garage or Home.

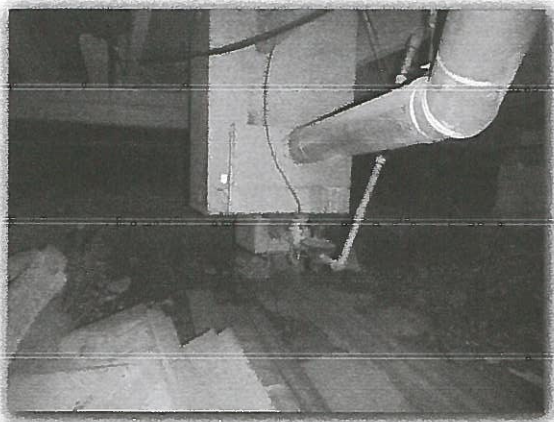
No Asbestos was discernible at these.

- **All Vent Ducts from Floor Heaters** can be stripped from the Home.
